FIELD SAFETY NOTICE ALERT

Team3 Fetal Monitor

Resolution in summary:	Upgrade Fetal Monitor with revised software (v19.4.1)
No pages:	15 inclusive of the declaration form

FSN01-23 Rev 2

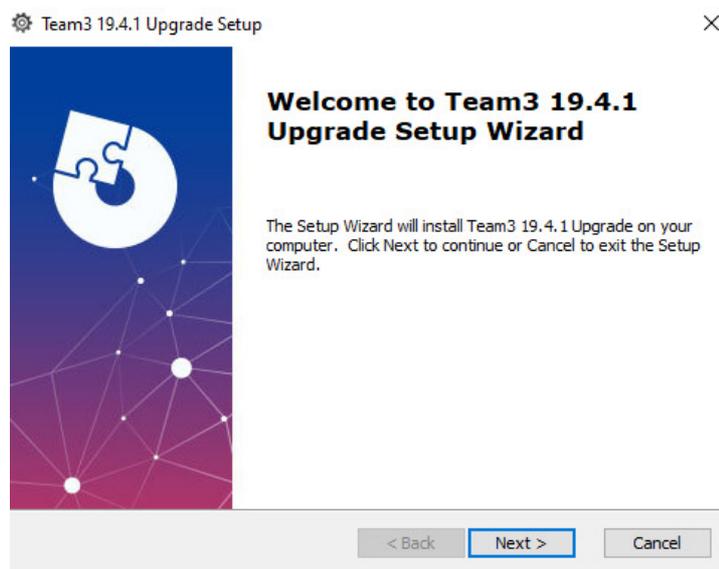
Once downloaded, run the executable 'Team3 19.4.1 Upgrade.exe' to install the software on the PC. Right click on the executable, select 'Run as administrator', and enter administrator credentials. The Setup Wizard will be displayed:

Follow the steps of the Setup Wizard to complete the installation.

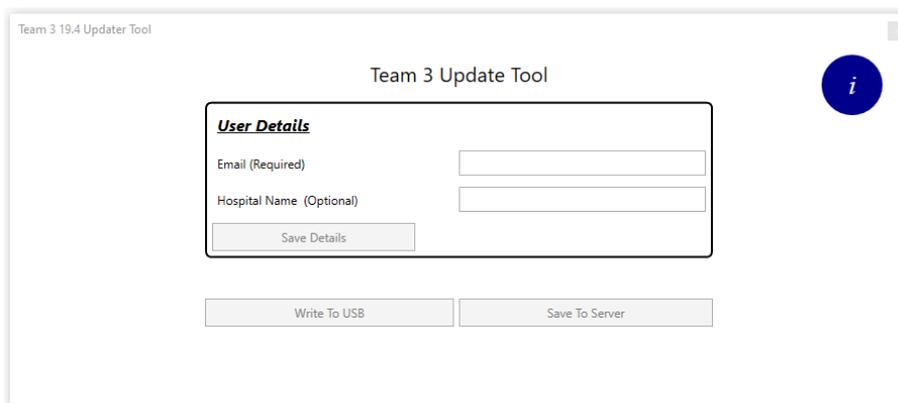
The following main screen will be displayed. Note that on first run, all of the control buttons are greyed out and unavailable. This will be the case until a valid email address is entered in the appropriate field.

- Enter a valid email address – the 'Save Details' button becomes available
- Optionally enter hospital details and click on 'Save Details' button
- Click on 'Write To USB' button which is now available

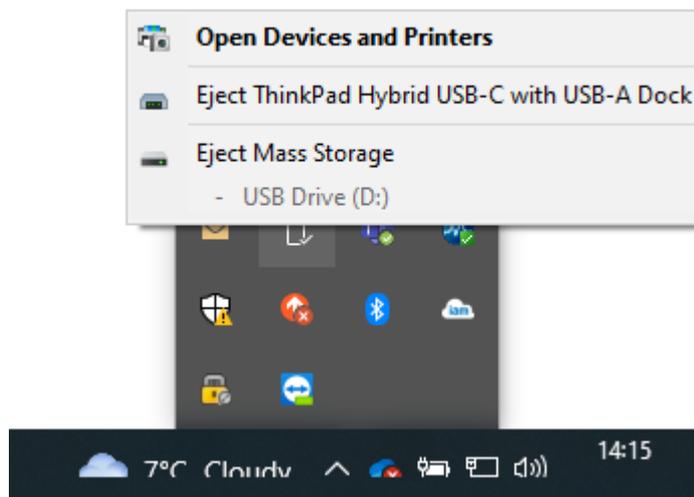
The 'Configure USB Device' dialog will be displayed providing a drop down list of all the USB devices of the appropriate size connected to the PC.

Select the correct device from the list and click the 'Configure USB Device' button. A warning will indicate that the contents will be erased - click 'Yes' to confirm the operation. The device will be formatted to FAT32 after which the upgrade files will be written to it. On successful completion, a notification will be sent to the Huntleigh server indicating that an upgrade USB stick has been created, provided a connection can be made. The whole process will take about a minute.

Close the dialog box and exit the application.

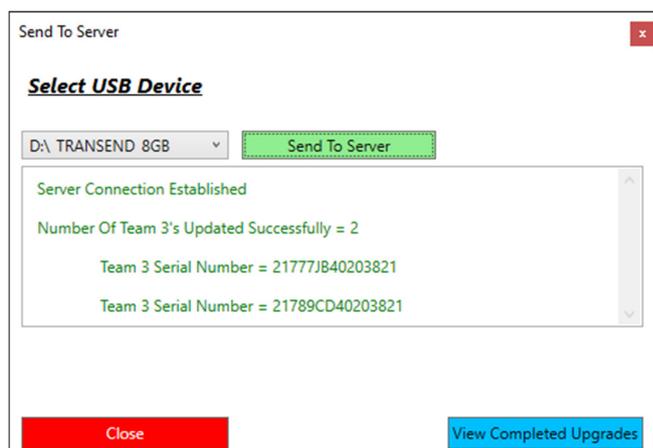
Click on the 'Send To Server' button to display the Send To Server dialog box.

Select the upgrade USB stick from the drop down list and click the 'Send To Server' button.

A list of the Team3 Units upgraded using the stick is displayed in the scrollable message box. If a server connection could not be made, please try again later.

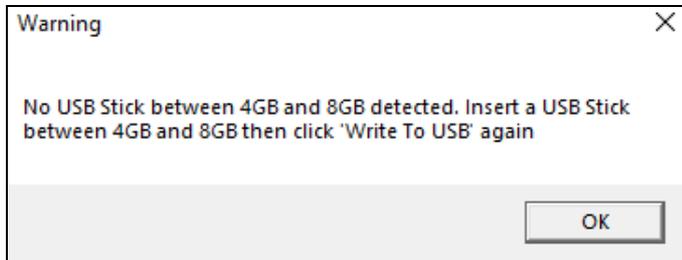
If there is no suitable USB memory stick inserted when trying to write the upgrade files, the following message is displayed:

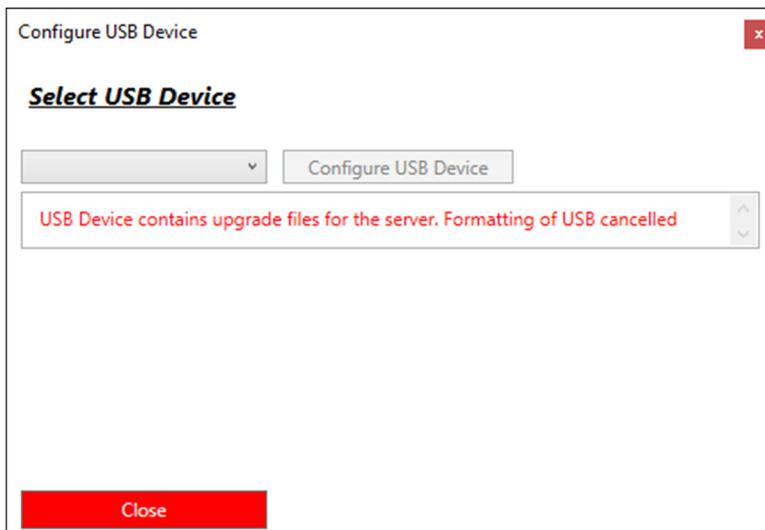
If the USB memory stick contains log files created during an upgrade operation, the following message is displayed when trying to write the upgrade files:

In this case, close the dialog box and replace the USB stick to before trying again.
