## URGENT Field Safety Notice

M5071A (adult) and M5072A (infant/child) pads for use with HS1/OnSite/Home AEDs may experience gel separation and reduction of gel surface area

21-FEB-2022

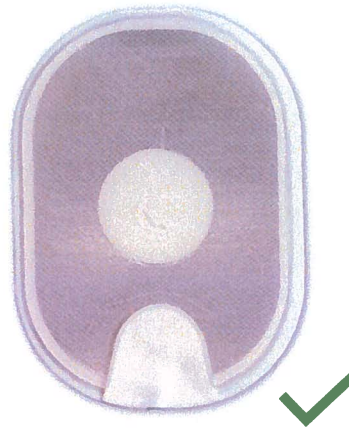
**Figure 4:** Normal pad.

Action:

Apply pads to the patient according to the Instructions for Use/Owner's Manual.
