URGENT Field Safety Notice

MR Systems: Patient support floor plate cage installation issue leading to potential for tipping

16-May-2024

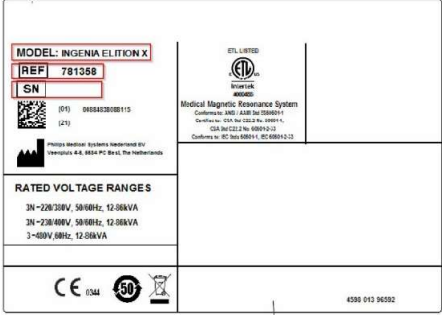
Potentially impacted systems can be identified by the Model and REF number (REF). The Model name and REF can be found on the system label, as indicated by the red boxes in Figure 2.

Figure 2. System label Example
All MR systems
