URGENT FIELD SAFETY NOTICE

ASTOPAD

FSN Ref. # 2023- 11 _en

FSCA Ref. # 2024- 01 _en j

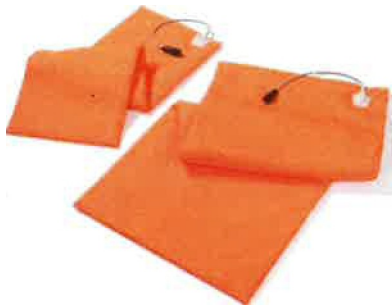
COV applied parts (blanket)

SOF and COV applied parts manufactured from May 2022 to October 2023 may potentially have internal (not visible from outside) damaged electrical insulation at a few distinct locations. The root cause is an error in the manufacturing process of the heating element. The damage could lead to localized overheating. This was identified during internal investigation after a single reported adverse event in which a patient received a burn approx. 3 cm in diameter.

The manufacturer will provide an adapter for all affected applied parts. To supplement the existing circuit protection in the control unit, the adapter contains an additional fuse that opens when the electrical contact conditions described above are met. Instructions to connect the adapter to the affected applied parts will be included. Once properly connected per the instructions, the adapter must not be removed.
