# Medical device field action

## HeartSine® samaritan® PAD

**SAM 350P/SAM 360P/SAM 450P/SAM 500P**

**Field action number: PR4280335 – FA319**

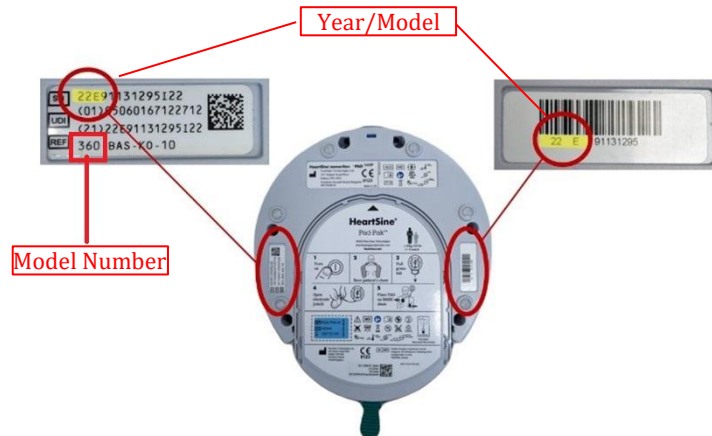
*Figure 1 – Serial & Model Number location*

- 1) To find your device serial number and model number, see the labels on the rear of your device as shown below:
