**To the Customers of the  
Dräger VentStar Resus Neo / VentStar Resuscitaire**

### **Important safety notice!**

#### **Possible leaks due to cracks**

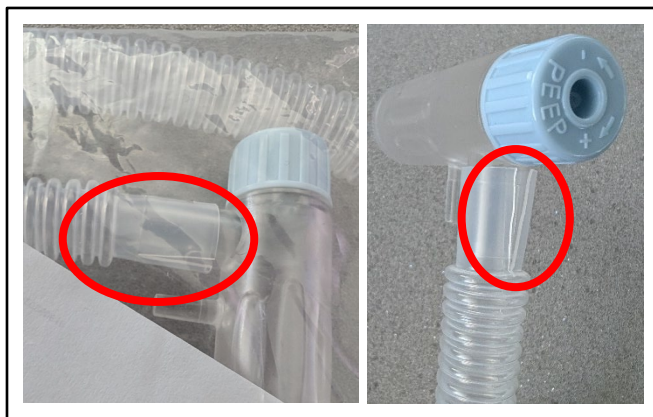
As part of our global market monitoring, we have become aware of cases in which obvious cracks in the hose of our VentStar Resus Neo and VentStar Resuscitaire were detected by the users prior to use. In no case we were informed of any negative effects on the health of the affected patients. However, this cannot be completely ruled out if such crack remains undetected.

**In case a cracked hose is used, the hose could fall off or leakage will occur. Depending on the leak, ventilation will be restricted and therapy could be delayed potentially resulting in desaturation, hypoxia or patient death.**

Our analyses revealed that affected hoses developed cracks shortly after the manufacturing and assembly process. Stress tests on “flawless” hoses have shown that they can safely be used as always.

**Fig. 1. Cracked hose with PEEP valve**

#### **1. Carefully inspect the hoses for damages prior to use according to the product's Instructions for Use (IfU).**

2. **Discard products that show cracks (Fig. 1) or have a detached hose (Fig. 2). You do not need to return them to us.**

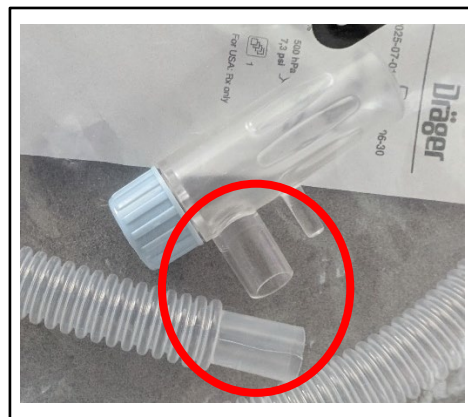
**Fig. 2: Detached hose/ PEEP valve**
