**To our customers of
Infinity CentralStation (ICS) VG3 or lower
And Edifier Speaker**

Important Safety Notice

The Edifier speakers (Purchased in or after April 2023) do not generate audio when the ICS is configured to analog mode and the speakers revert to USB mode.

Affected Devices: Infinity Central Station (MS26800) VG3.0 or lower and Edifier speakers (MS34036). See Attachment 1 to identify the affected speaker.

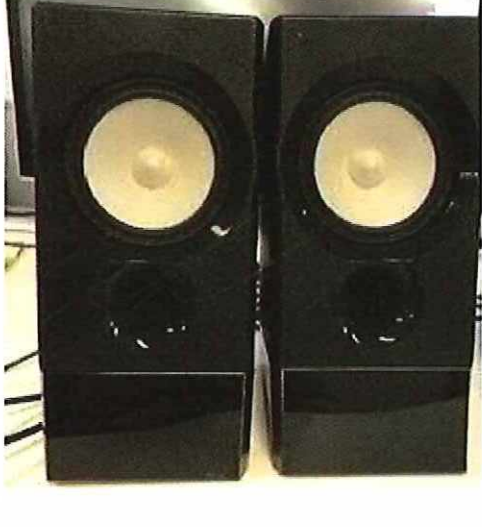
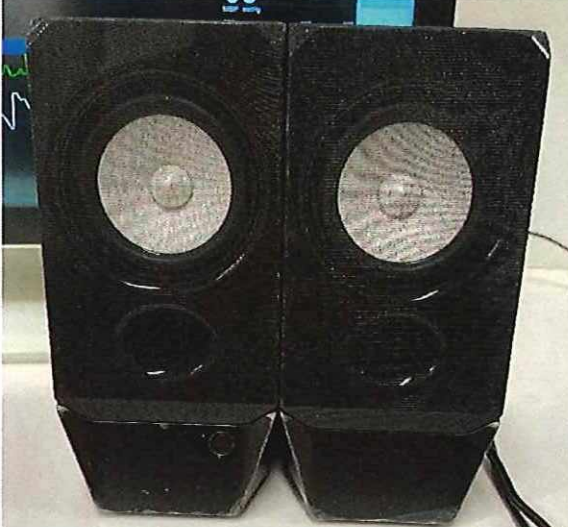
Attachment 1: Identification of New Speaker and Differentiation Between Old and New Speaker

Old Speakers	New Speakers

<p>Note the square bottom, no button, and no light.</p>	<p>Note the angled bottom, button, and red/green light.</p>

According to our records, you have received at least one affected ICS VG3 or lower (MS26800) manufactured by Draeger Medical Systems, Inc. (European Single Registration Number: US-MF-000020721, UDI: 04049098001878) and have ordered and received the new Edifier speakers (MS34036, UDI: 04048675548027) that may be affected by this issue. The new speakers can be identified by locating a light on the front face and to differentiate between old and new speakers, the old Edifier speaker have a flat façade with no light (see **Attachment 1**).

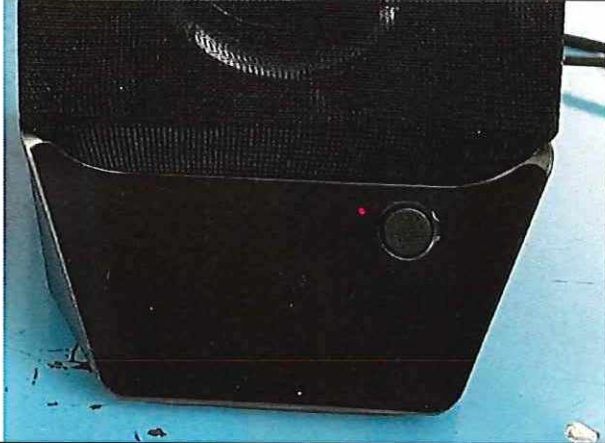
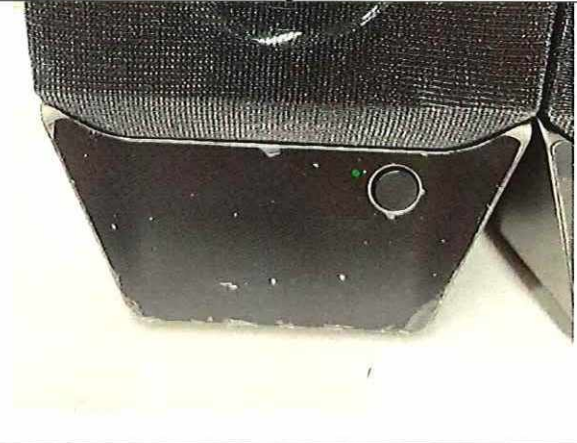
Attachment 2 : Identification of USB mode and Analog Mode through a color of light on front of the new Edifier Speaker

USB Mode	Analog Mode

Red Light – the Speaker is in USB mode	Green Light – the Speaker is in Analog Mode

1. Connect USB cable first.
2. Connect Analog Cable.
3. Verify that the green LED is displayed on the speaker. If the LED is not green, then the Analog cable should be disconnected and then reconnected. **See Attachment 2.**

- You MUST physically disconnect Analog cable and then re-connect from the speaker to put the device back in Analog mode (Green LED) or else there will be no sound.

- You MUST disconnect and re-connect the Analog cable to restore the speaker to Analog mode (Green LED).
